NASA TM X-73390

## INVESTIGATIONS FOR THE IMPROVEMENT OF SPACE SHUTTLE MAIN ENGINE ELECTRON BEAM WELDING EQUIPMENT

By R. A. Smock, R. A. Taylor, and W. A. Wall

April 1977

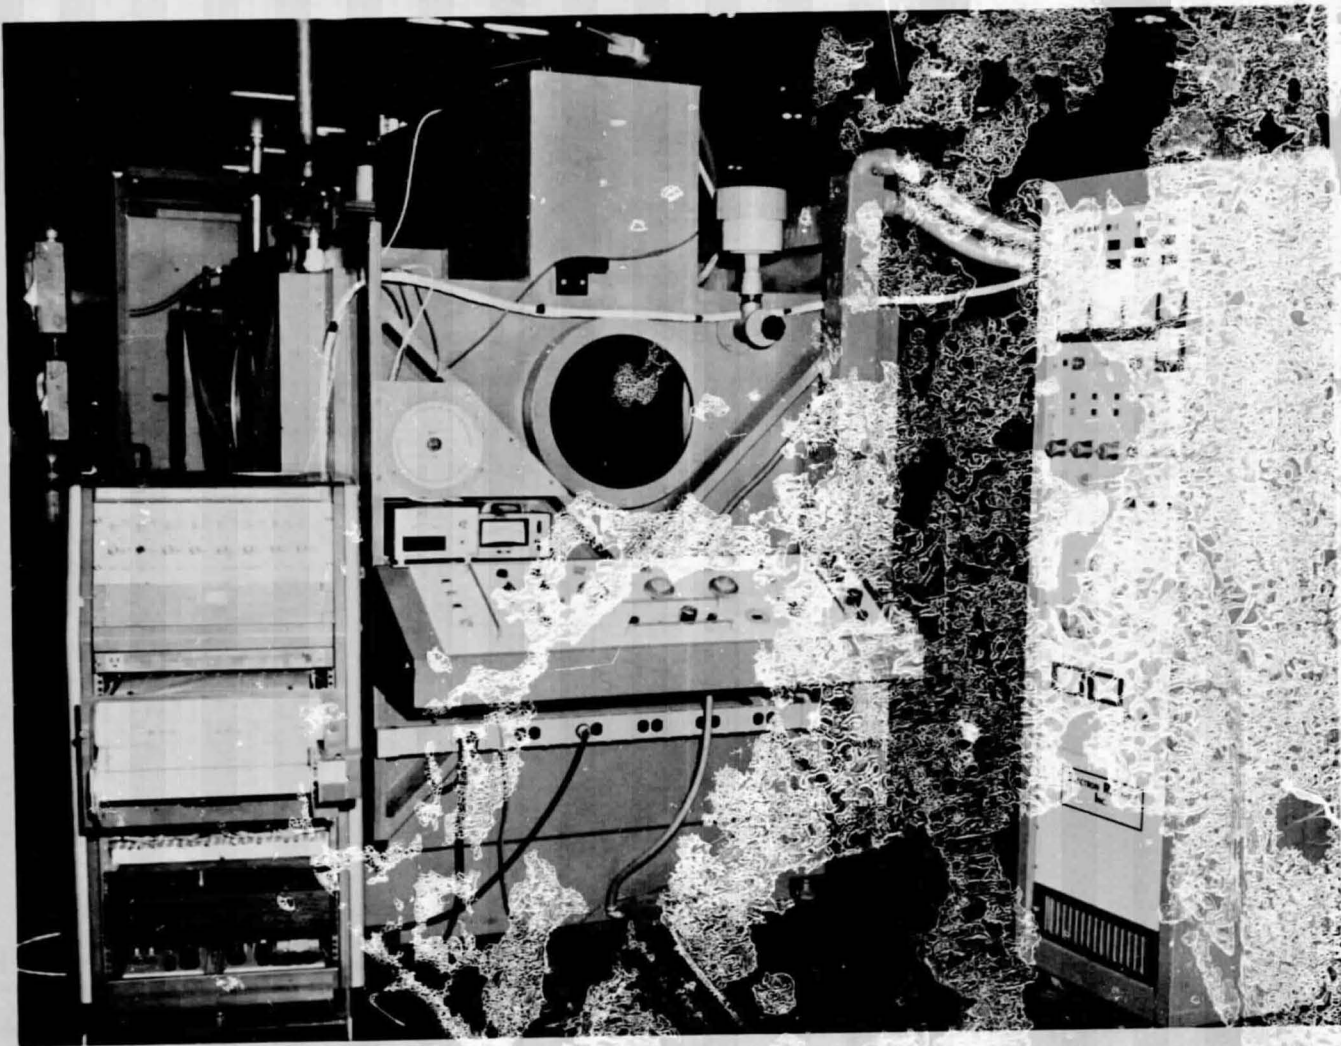
Figure 1. ERI DCC LP welder, shown instrumented.

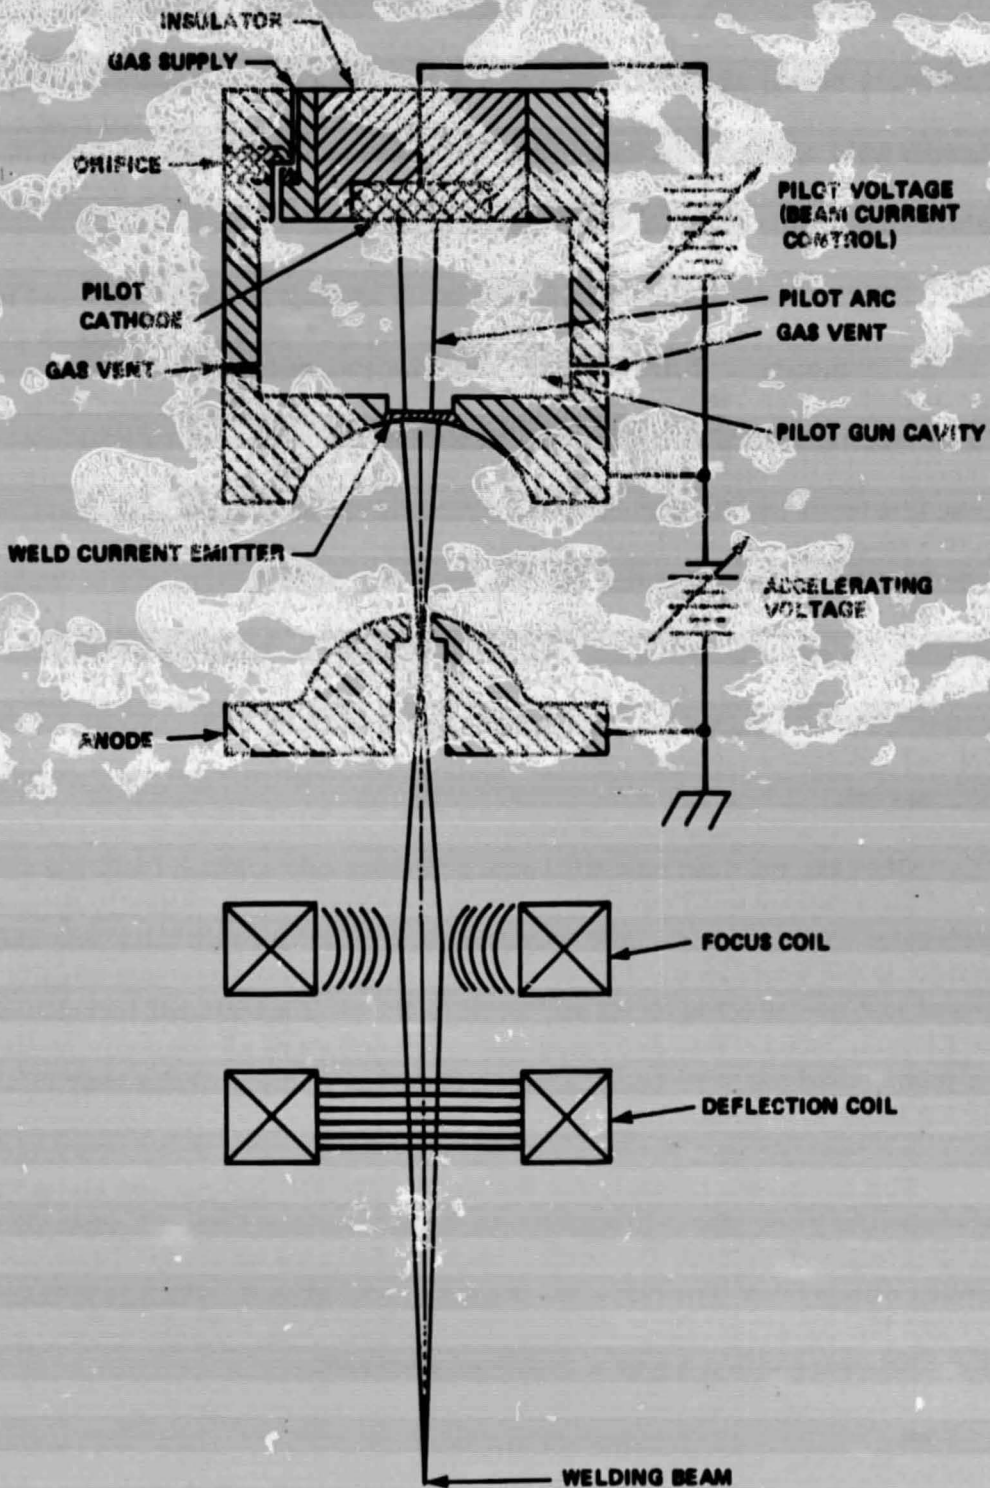
Indirect heating is accomplished by an ionization beam, referred to as the pilot arc (Fig. 2), which normally operates at a nitrogen ionization pressure of 50 to 150 microns. Nitrogen is fed from an external source through a replaceable 0.0127 mm (0.0005 in.) orifice in the EB gun and into the pilot gun cavity at a nominal rate of 0.5 to 5 SCCM. In the pilot gun cavity, the nitrogen gas interacts with the pilot voltage to create ions and electrons by field emission. These electrons bombard and heat a small spot in the center of the weld current emitter to electron thermionic emission temperature. The ionization gas then exits the pilot arc cavity through two adjustable vents and escapes to the workchamber. Gas flow, therefore, is a function of the source pressure, orifice leakage rate, and gas vent adjustment. Thus, the necessary weld current emitter heat is a function of the ionization gas pressure and the pilot arc voltage. Within the ionization gas pressure range in the pilot arc cavity, the pilot arc voltage is closed-loop, feedback controlled to maintain the required weld current.

Figure 2. Electron beam gun, simplified diagram.
